Southern Trails Chapter Members Take On Repair Of Historic Marker

The monument at Navajo Springs, Arizona, honoring establishment of the first Arizona territorial government in 1863, was broken and ignored.

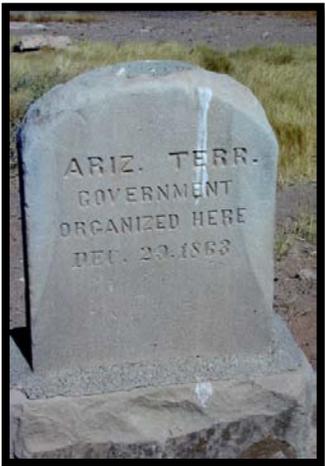
Marker as it appeared in 2001

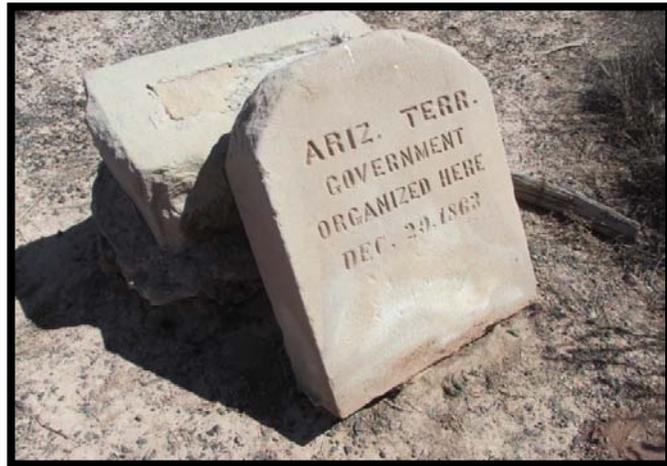
Marker after it was broken

Although the original marker remained upright for nearly a hundred years it is clear why it got broken. The original marker was hauled to the springs site and set in a relatively small concrete footing that was poured on site. The result was a marker that probably weighed 700 pounds sitting on a concrete footing that weighed maybe 200 pounds. When erosion washed away some of the dirt supporting the footing, the marker fell over. The original marker was and is a very nice marker. When it fell over, the upright part of the marker separated from the original base.

Neither part was substantially damaged. Richard Greene and Tracy decided to repair it in such a way that it might last 200 more years. Trying to do this work in the middle of the desert, 175 miles from Prescott, would be really difficult. It was decided to travel to Navajo Springs, collect the marker and return it to Prescott where it could be properly repaired. The original marker pieces weighed about 350 pounds apiece. We used Tracy's four-wheel drive van and an engine hoist to load the marker pieces into the van.

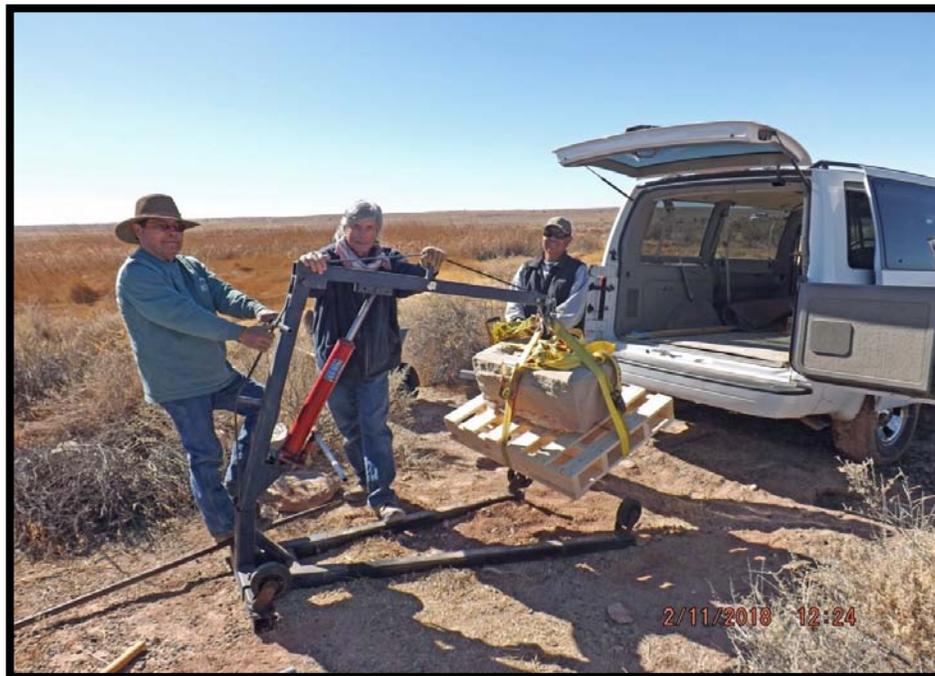
Clarence Bedonie, Richard Greene and Al Pahi loading the marker base into Tracy's van

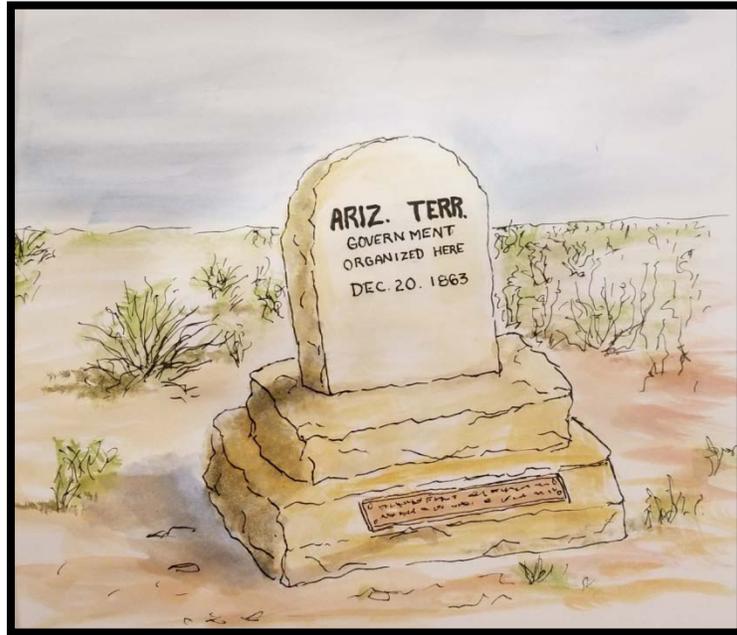
It was decided that a new base would be cast from concrete. The repaired marker, with its original base would sit on the new base. The new base would be substantially larger than the original 200-pound footing. The rendering below gives an idea what the repaired marker will look like. The new base will be even larger than that depicted in the drawing, probably weighing about 1400 pounds.

Drawing showing how the restored marker will appear

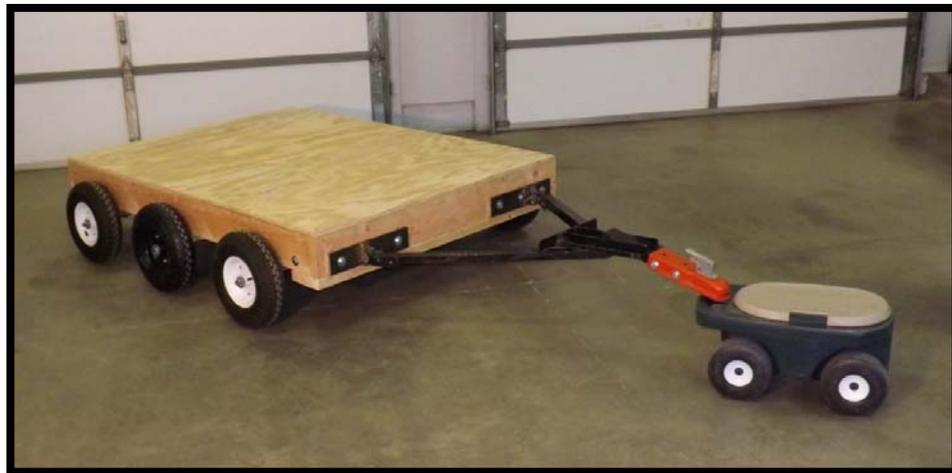
Although they were able to move the two pieces of the original marker it was soon clear that the repaired marker would weigh about 2100 pounds. In order to move the repaired marker around and transport it back to Navajo Springs, we were going to need a substantial cart. The first task was to construct such a cart. Since we will have to move it with a motorized vehicle, we also fabricated a trailer hitch for the cart.

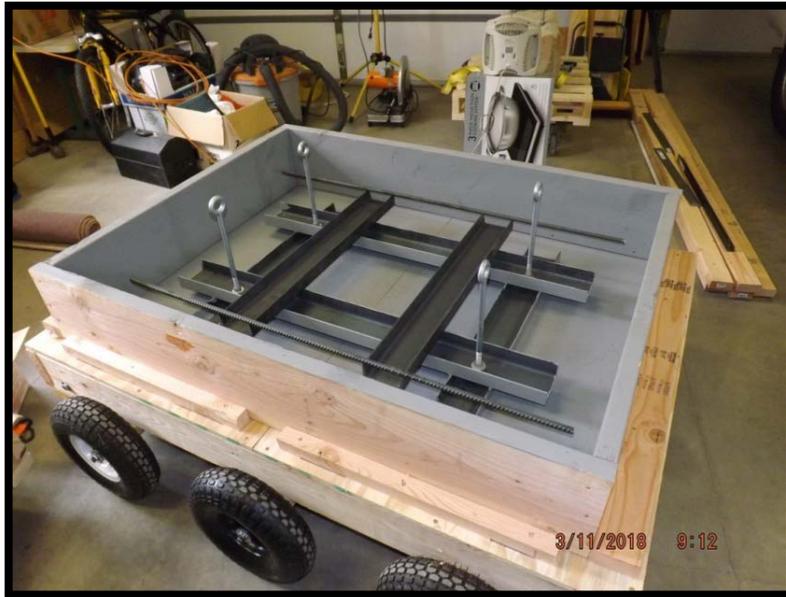
The next step was to figure out how to attach the original marker base to the new base. It was decided to reinforce the new base with structural steel and attached the original marker base to the structural steel. The photo below shows the dolly with the form that will be used to cast the new marker base. Inside the form is the structural steel with the eye-bolts in place that are required to lift the marker when it is complete.

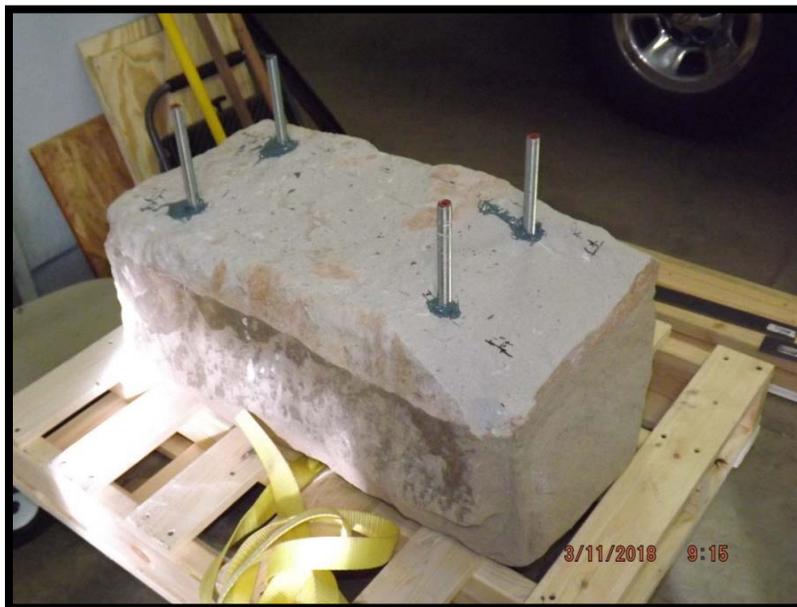
In order to attach the original marker base to the structural steel, four threaded rods were inserted into holes in the bottom of the original marker base and locked into these holes with industrial epoxy (see photo below).

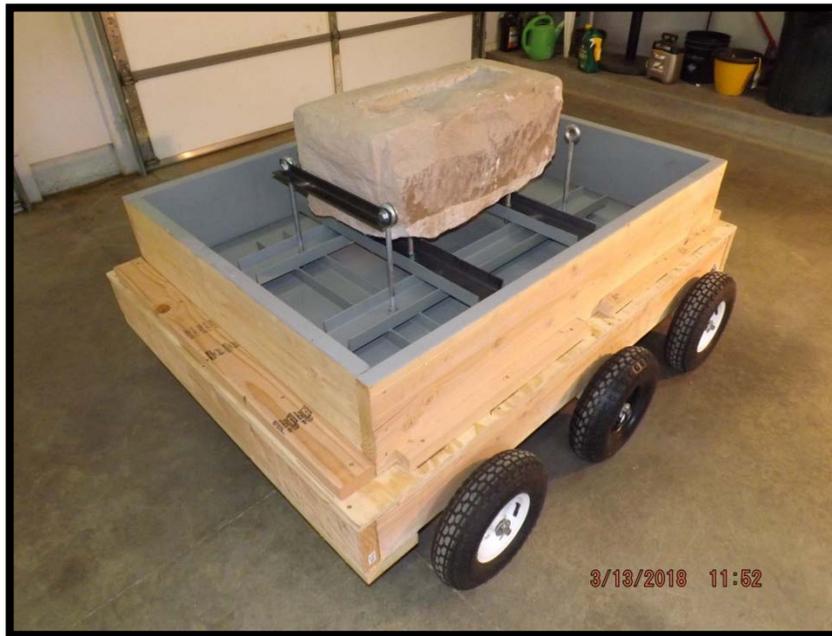
The next step was to bolt the original marker base to the structural steel. A number of additional steps were needed to before we were ready to cast the new concrete base.

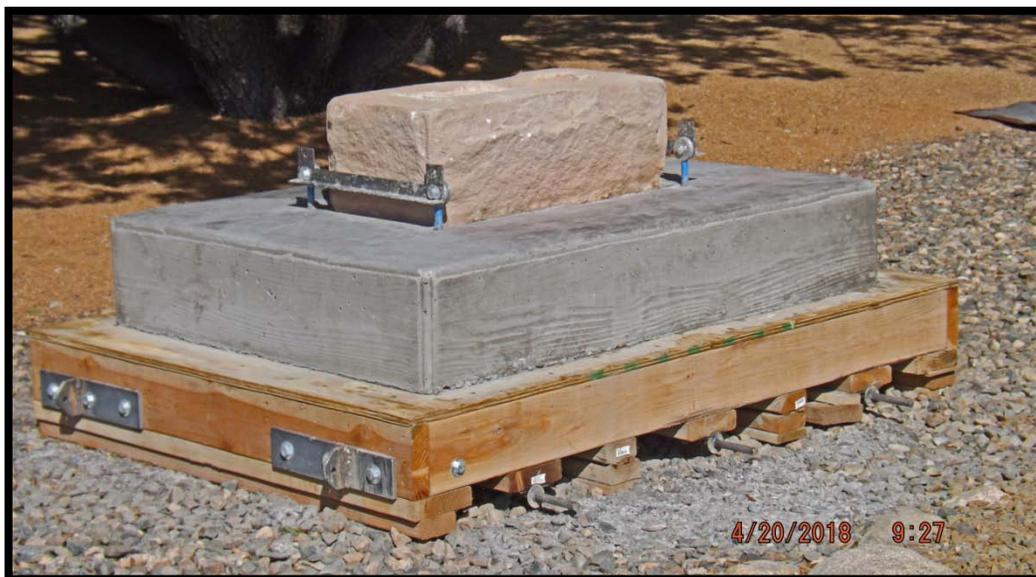
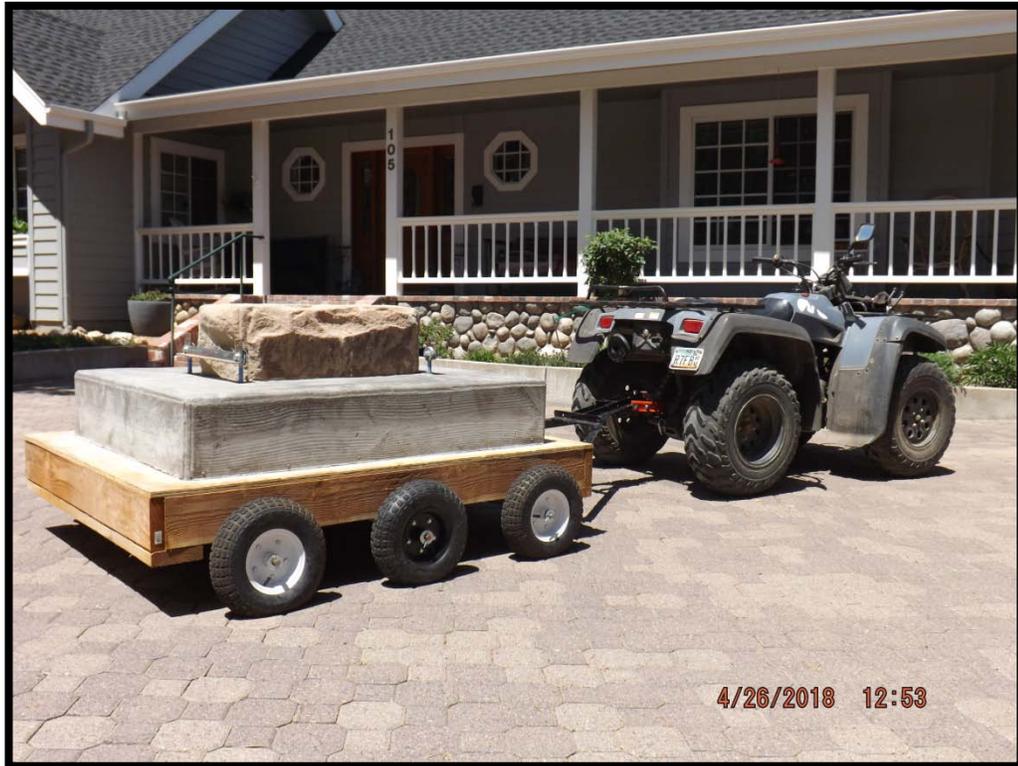
On April 19th the new concrete base was cast. We kept it wet for seven days as the concrete went through the initial cure phase. (Concrete takes twenty-eight days to fully cure.)

The new concrete base with the original sandstone marker base now weighs over a ton. It can only be moved on the cart with the muscle afforded by a quadrunner.

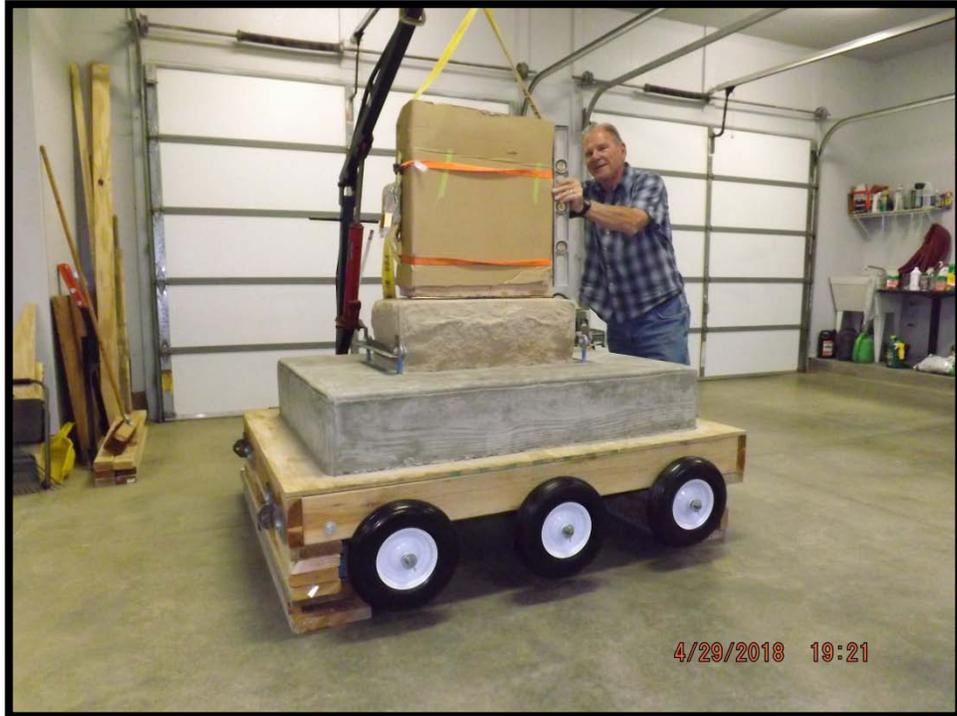
Checking the fit before attaching the upright part of the marker to the original base

We are now ready to reattach the upright part of the marker to the original base. When the marker was originally constructed, the upright part was attached to the original base with some sort of cement. This worked well and it would probably still be attached if it had not fallen over. We plan to use three steel rods to attach the upright part of the marker to the original base. We will also fill the gap between the upright part of the marker and the original base with industrial epoxy. Once the epoxy has set up, it should be almost impossible to ever separate them again.

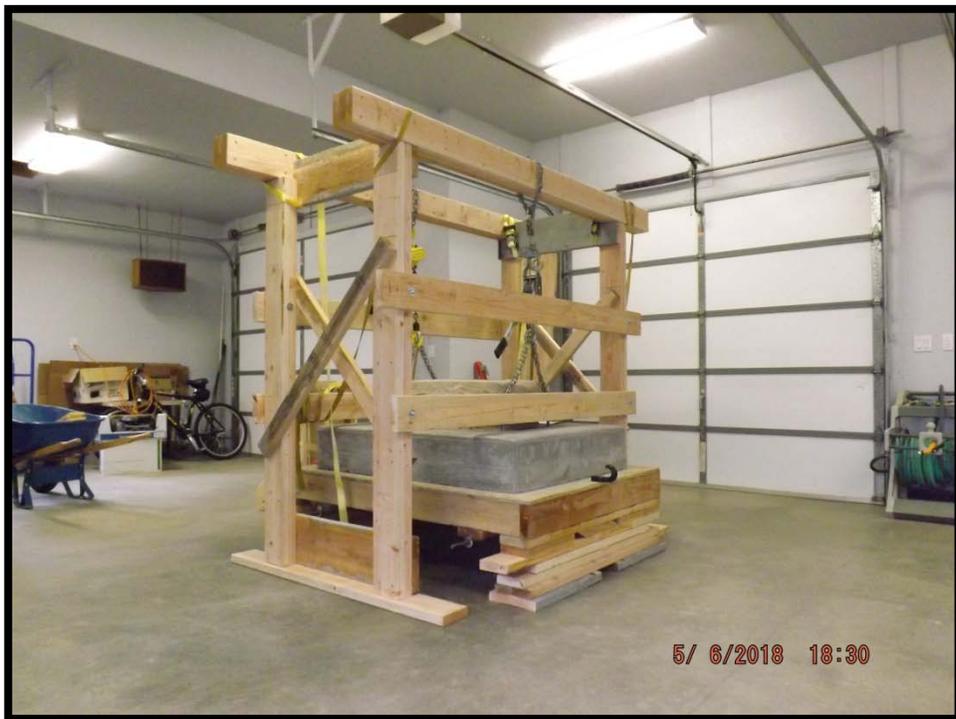
Gantry for lifting the repaired marker and the new concrete base off of the cart

Up to this point we have been able to lift the marker pieces using an engine hoist and lift the cart carrying the new concrete base with a rolling floor jack. Neither of these lifting devices will work to lift the finished marker off the cart. What we're going to need is a gantry and a pair of heavy-lift chain hoists.

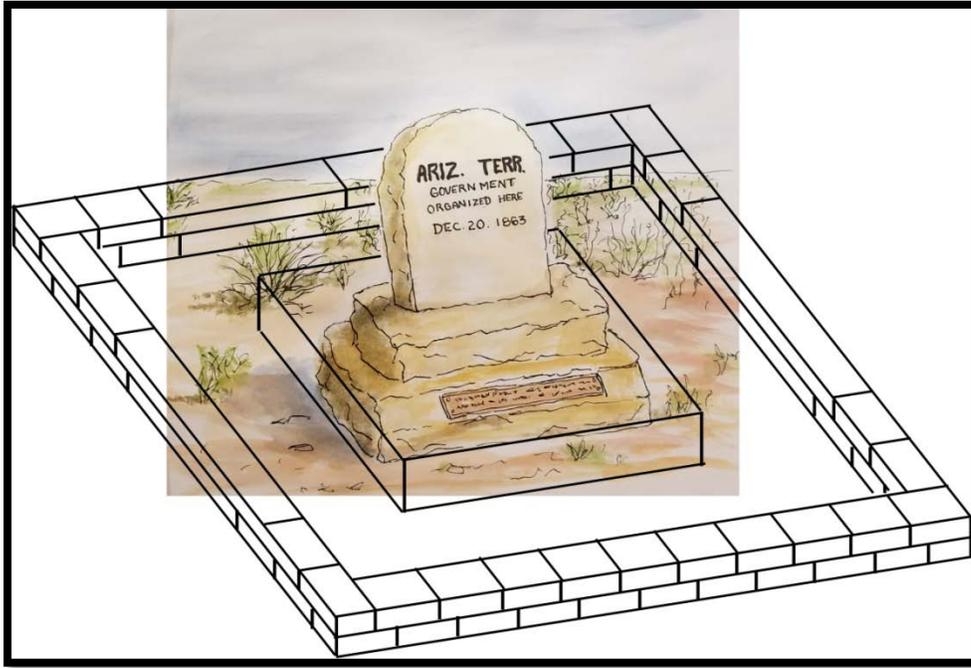
While the final repairs are being made to the marker, a trip will be made to Navajo Springs to prepare the site for the repaired marker. We plan to level an area of about forty square feet. We will then build a low retaining wall from precast concrete stones. The enclosure will then be filled with driveway gravel.

Finally, the new concrete base will be waterproofed. When the repairs are complete, the repaired marker, setting on the dolly, will be loaded onto a car-hauler trailer and taken back to Navajo Springs. The quadrunner will be used to move the marker/cart across the desert and back to where the marker was originally placed.
